MacKenzie Environmental Education Center Study
Wisconsin Department of Natural Resources and
Wisconsin Department of Administration
October 2014

Section 9101 (2i) of 2013 Wisconsin Act 20 directed the Department of Administration (DOA) to conduct a “thorough review of the existing status and condition of the buildings, structures, and animal enclosures at the MacKenzie Environmental Education Center.” The study was to include “a description of the maintenance and repairs that are necessary for the buildings, structures, and animal enclosures with an estimate of the costs of doing the maintenance and repairs.” The DOA Division of Facilities Development (DFD) engaged the services of INSPEC, Inc., an independent engineering/architectural firm to undertake the study.

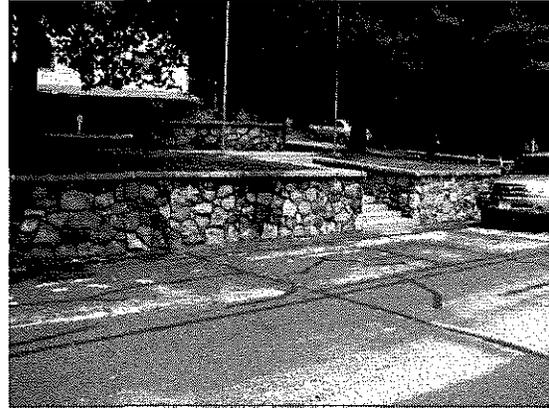
Retaining Walls

The retaining walls throughout the site are generally constructed of cobble stones and mortar. The walls vary in condition from good to failed.

Recommendations vary from tuck-pointing mortar joint to immediate replacement.

The estimated construction cost to repair and maintain the retaining walls is estimated at \$337,500. Approximately \$300,000 of this cost relates to the full reconstruction of 950 linear feet of retaining wall and associated pavement, fencing, and concrete curb at the Administrative Office building.

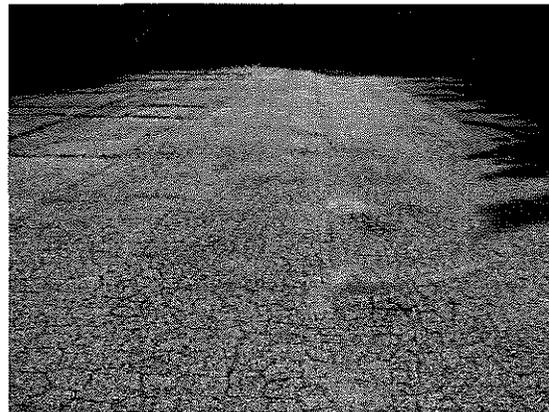
Pavement

The pavements throughout the site are constructed of either asphalt pavement over base aggregate, asphalt pavement overlay over concrete pavement, or concrete pavement. Past pavement maintenance included crack sealing, slurry sealing, pot hole filling, and asphalt pavement overlays.

Pavements in good condition were recommended to receive routine maintenance. Pavements in poor condition were recommended for reconstruction. The estimated construction cost to repair and maintain these poor areas is \$1,680,000.

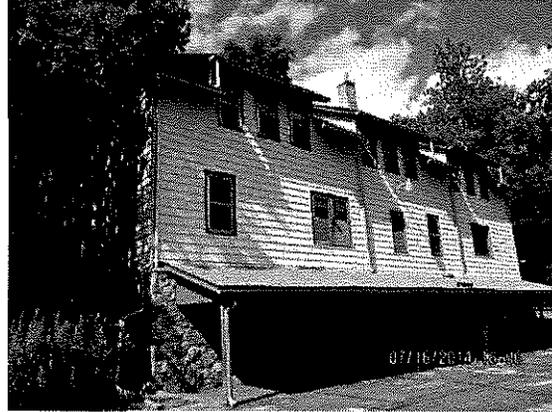
The building is used for offices and provides the only public, ADA accessible bathrooms. The basement is ADA accessible with at grade access to an office and the bathrooms. The first floor offices are accessed by the original interior stairway and a secondary exterior entrance. The second floor is office space but there is no secondary means of egress.

The building is in structurally sound condition and is sited properly for accessibility and parking. The second floor could provide more office space if a secondary means of egress were provided. The Administrative Offices building provides viable office space options for future consideration.

The estimated construction cost to provide the secondary means of egress and to keep the facility viable for continued use (roof replacement and systems upgrades) is \$131,900.

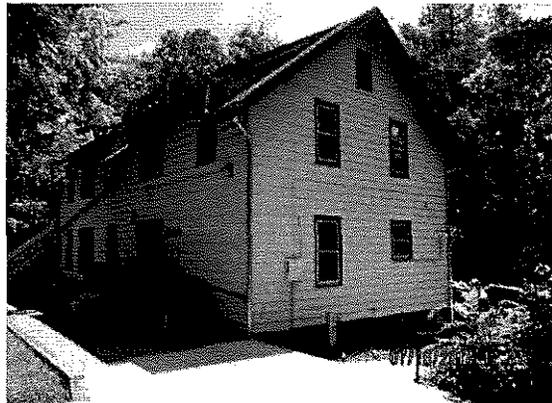
Badger Den

The building is in structurally sound condition and is sited properly for parking and access. The Badger Den's proximity to the Administrative Building makes it a valuable and adaptable long-term asset for the Center.

The estimated construction cost to keep the facility viable for continued use (roofing, new handrails, systems upgrades, window replacements, etc.) is \$143,050.

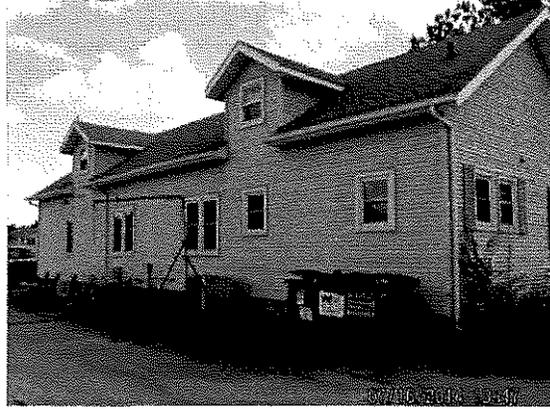
The building is in structurally sound condition and is sited properly for accessibility and parking. The Game Farm Office building can provide viable office space for up to 10 occupants depending on task. The bathrooms must be modified to meet accessibility requirements to become ADA compliant.

The estimated construction cost to bring the bathrooms into ADA compliance and keep the facility viable for continued use (window and door replacements, masonry work, and systems upgrades) is \$90,750.

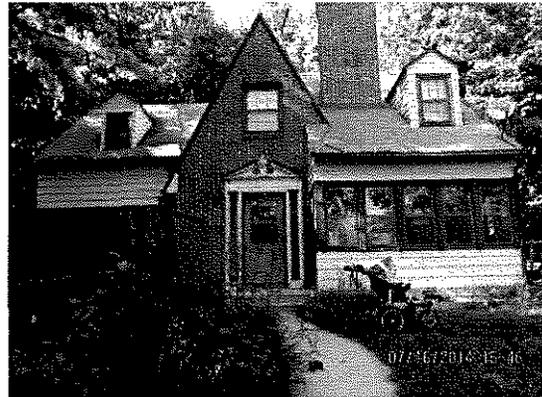
The Residence is not ADA accessible but this is not an issue because it is used as a private residence. It is constructed at an elevated grade in order to provide access via concrete ramp the basement garage. As a result, access from the driveway to the house entrance is an inclined concrete sidewalk to the entrance stoop with two steps. The drive and walk exceed ADA ramp design pitch. The estimated construction cost to keep the facility viable for continued use (window replacements and systems upgrades) is \$103,700.

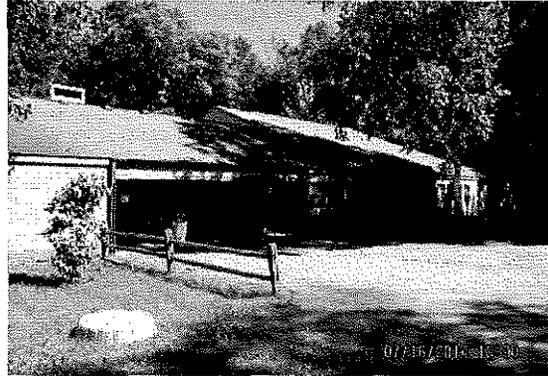
Lodge Resident Center

The building was substantially remodeled in 1999 including window replacement, re-siding, and the installation of a new roof. The building is in structurally sound condition. The open plan design makes it very adaptable for future function and use. None of the building entrances are ADA accessible with closers and hardware. One of the entrances should be identified and modified for accessibility.

The estimated construction cost to bring the bathrooms into ADA compliance and keep the facility viable for continued use is \$333,700.

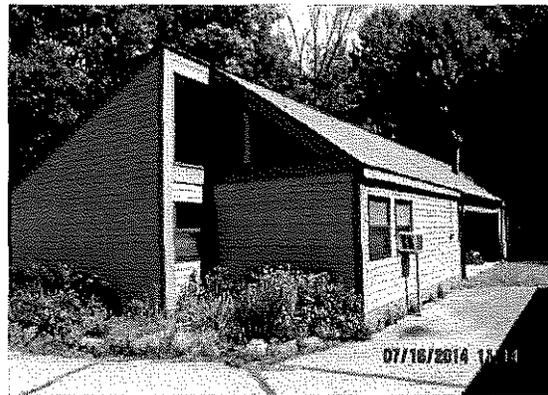
North and South Dormitory

Each building is in structurally sound condition. The open design provides an opportunity for building flexibility and function.

It is recommended that each building envelope be re-roofed, re-sided, and all window units replaced. The furnaces were replaced in 1999.

The estimated construction cost to bring the bathrooms into ADA compliance and make the recommended upgrades is \$237,700.

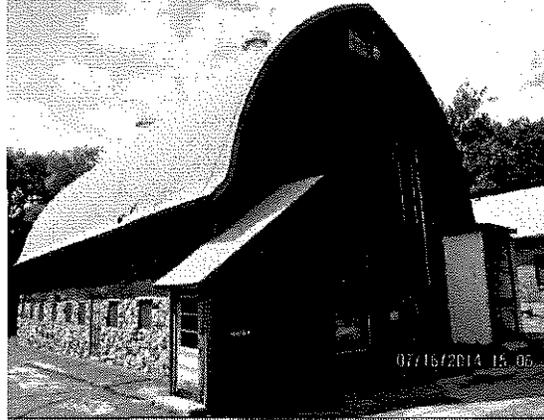
Museum

Future building utilization is dependent on the specific use or function. There are occupancy and use codes that are affected by the type of building construction and the specific occupancy. Because of these considerations and the need for a controlled interior environment, the current barn structure is not conducive for use as museum occupancy. The future use of this facility as a museum has not been determined.

The estimated construction cost to keep the facility viable for continued current use (roof and siding replacement, and systems upgrades) is \$96,650.

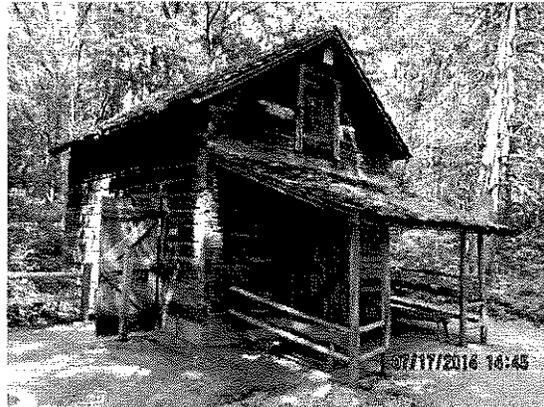
Logging Museum

The base of the wood structure bears directly on the concrete foundation. This wood is susceptible to moisture and deterioration. The logs are beginning to show signs of rot. The logs should be treated and flashings should be installed to stabilize the rot condition.

The sawn-wood shake roof shingles have excessive moss growth on them and they are beginning to deteriorate. The wood shingles should be replaced.

The estimated construction cost to make the recommended upgrades to keep the facility viable for continued use is \$17,500.

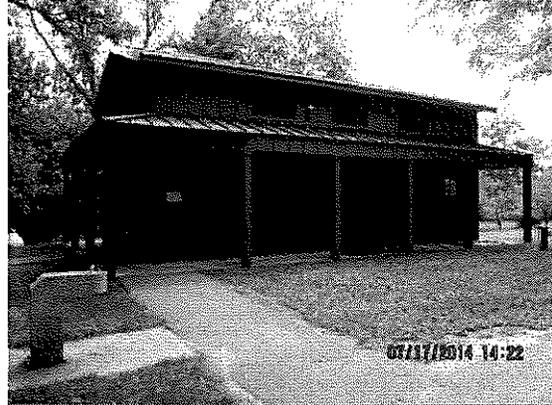
Maple Syrup Finishing Structure

The building is good overall condition. It could be improved by: insulating water piping; providing emergency egress lighting throughout the egress paths by replacing exist signs with combination exit and emergency battery units; and installing an exhaust fan and wall vent for the janitor closet. The estimated cost for these improvements is \$2,000.

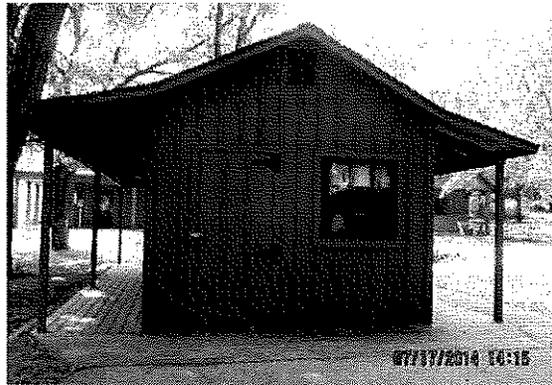
The Wallen Sugar House is a 312 GSF building constructed in 2004. The building is in good condition. The asphalt shingle roof and board and batten cedar siding are original.

The building can be improved by providing emergency egress lighting throughout the egress paths by replacing exist signs with combination exit and emergency battery units. The estimated cost for the improvements is \$1,250.

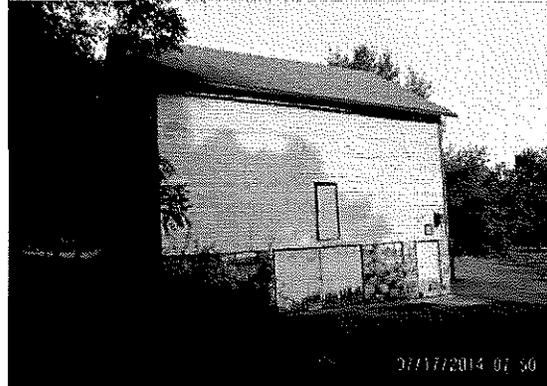
The Barn is a post and beam structure that was constructed around 1900. The building is constructed on a stone and masonry foundation in the side of a hill exposing the foundation for access. The 40' x 30' structure has 1,200 GSF for lower level storage, 1,200 GSF of first floor storage and a partial hay loft.

The estimated construction cost to keep the facility viable for continued use (new roof and painting) is \$21,400.

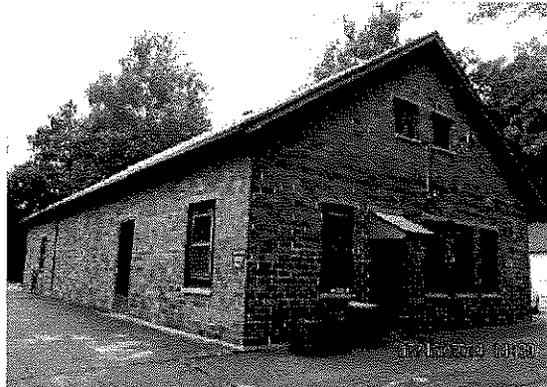
Shop

The building has extremely limited utilization. While it is constructed well, it will require major modifications to make useable for anything other than its current use.

The estimated construction cost to keep the facility viable for continued use (roof and window replacement and systems upgrades) is \$62,500.

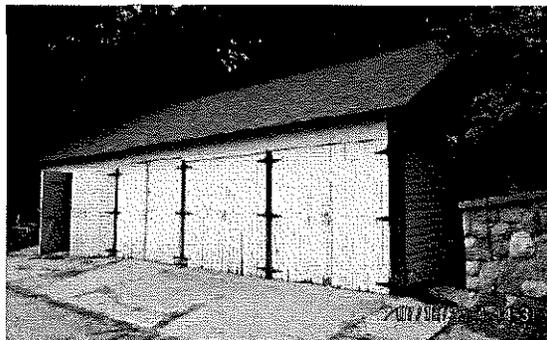
The Garage has limited use. Future utilization is limited to storage. If it is determined that the Garage is needed for continued operations, re-roofing, painting, and new overhead sectional doors with operators are recommended. The estimated construction cost to make the recommended upgrades to keep the facility viable is \$17,000.

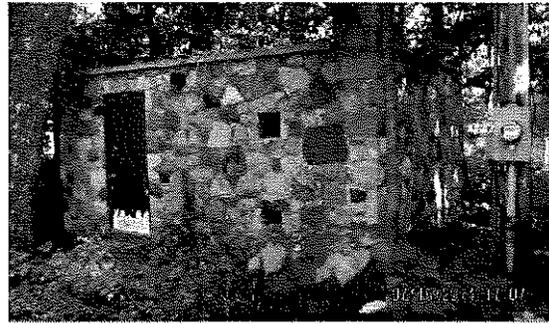
Power House

The building has remained substantially unchanged since it was first constructed. The building door is in poor condition and should be replaced.

The estimated construction cost to keep the facility viable for continued use (new roof and doors, masonry repairs, new distribution equipment) is \$14,300.

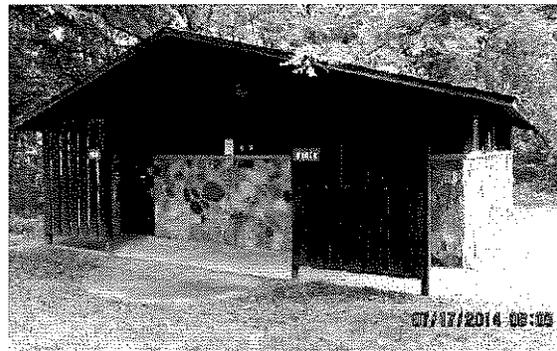
The Seasonal Toilet Facility was constructed in 1972. It houses both men's and women's toilet room facilities. It is not fully accessible and lacks adequately sized toilet enclosures and turning requirements.

Utilization is improved with accessible toilet rooms. The estimated construction cost to bring the facility into ADA compliance is \$42,750.

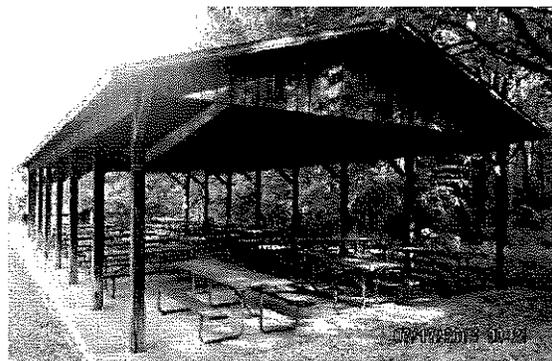
The Recreation Shelter is 1,200 GSF and was constructed in 1972 in conjunction with the adjacent Toilet Facility. The Shelter has a capacity of 40 people. The Shelter needs a paved pathway to provide an accessible route to the Shelter.

The estimated construction cost to keep the facility viable for continued use is \$8,000.

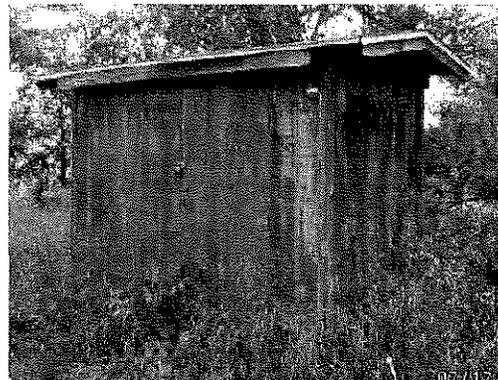
The Tool Shed is a freestanding wood framed building that houses firefighting gear. The 4' x 8' shed has no foundation, no utilities, and no pathway. The roof is in poor condition and needs replacement. Fascia boards are rotted and missing. The siding and trim need to be painted. The estimated construction cost to make the recommended upgrades to keep the facility viable for continued use is \$1,100.

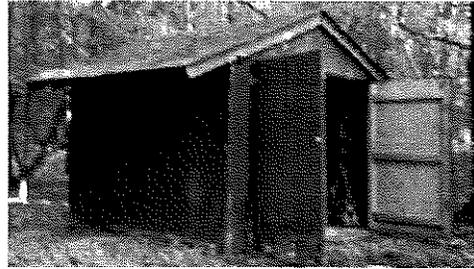
Storage Shed at Residence

The Storage Building at the Residence is a freestanding 10' x 10' wood framed structure with a gable roof. The siding requires painting and the shingled roof needs repair and replacement. The estimated construction cost to make the recommended upgrades to keep the facility viable for continued use is \$1,800.

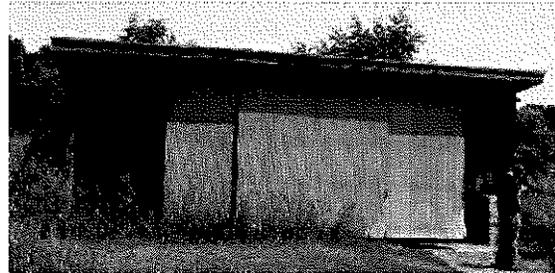
The Hay Storage Shelter is a 30' x 20' pole building structure. The building was constructed in 1950. The roof is asphalt shingles and the siding is corrugated steel and T-III plywood. It has sliding doors on the south side for complete accessibility. The building is in poor condition and requires re-roofing with fiberglass. The estimated construction cost to make the recommended upgrades to keep the facility viable for continued use is \$4,200.

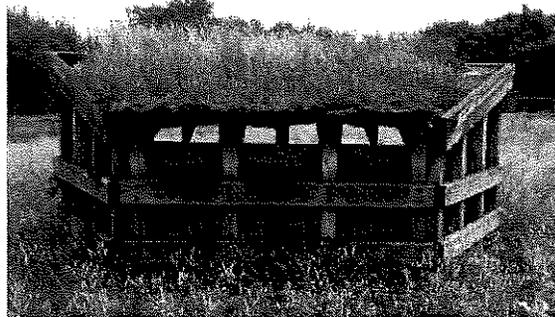
The **Bison Shelter** is a free standing heavy timber structure located in the middle of the bison pasture area. The shelter is 25' x 10' and was constructed in 1977. It has bolted connections and a single slope vegetative roof.

The estimated construction cost to keep the facility viable for continued future use (roof repairs) is \$5,000.
