Restoring the vision: the story of Wisconsin's Capitol Building, from its construction in the early 1900s, to its recent renovation

*Restoring the Vision:
The First Century of Wisconsin's Capitol*

by Michael J. Keane
Photo Design by Kathleen Sitter
Legislative Reference Bureau

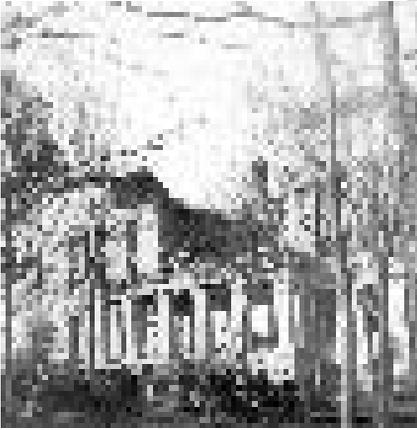
Five workmen were killed and 20 others injured when a wall collapsed during construction of the south wing extension in 1883. (State Historical Society, #WHi (X3) 25535)

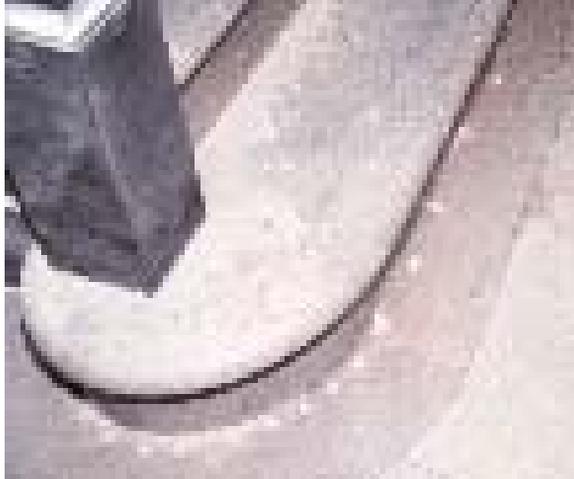
Damage caused by driving carpet nails directly into a marble floor. (Kathleen Sitter, LRB)

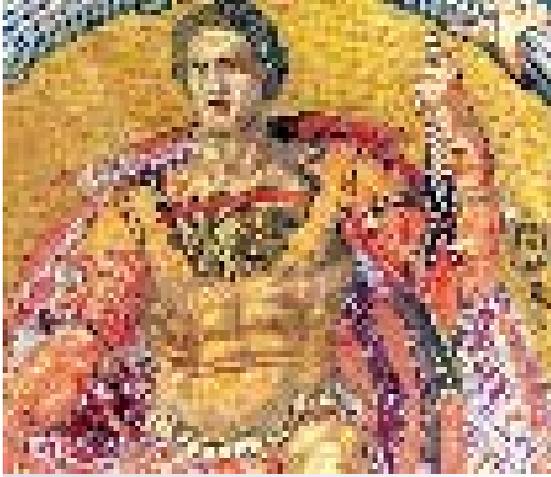
Portions of Kenyon Cox's mosaics were repaired with an inferior adhesive, marring their appearance. (Kathleen Sitter, LRB)

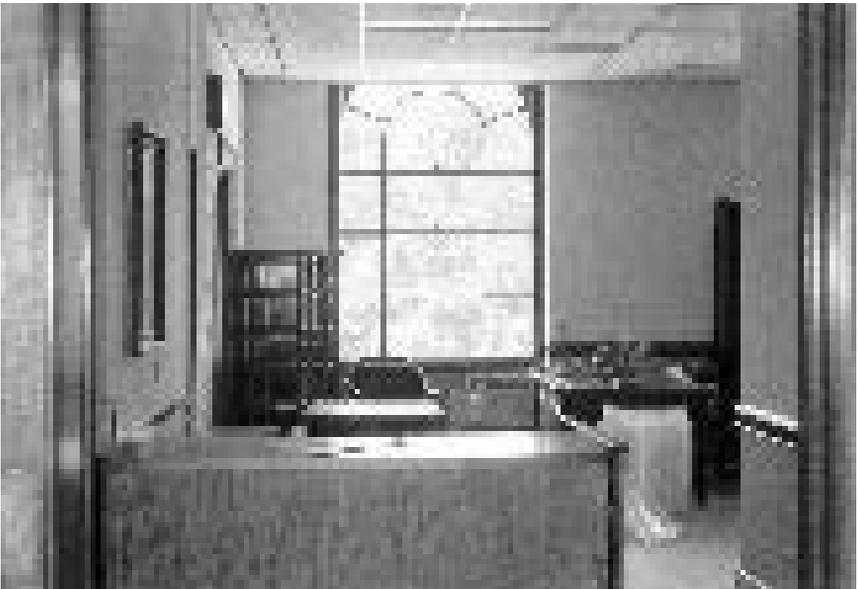
Acoustical ceilings were installed in many areas of the capitol without regard to the architectural integrity of the building. (East Wing Architects LLC)

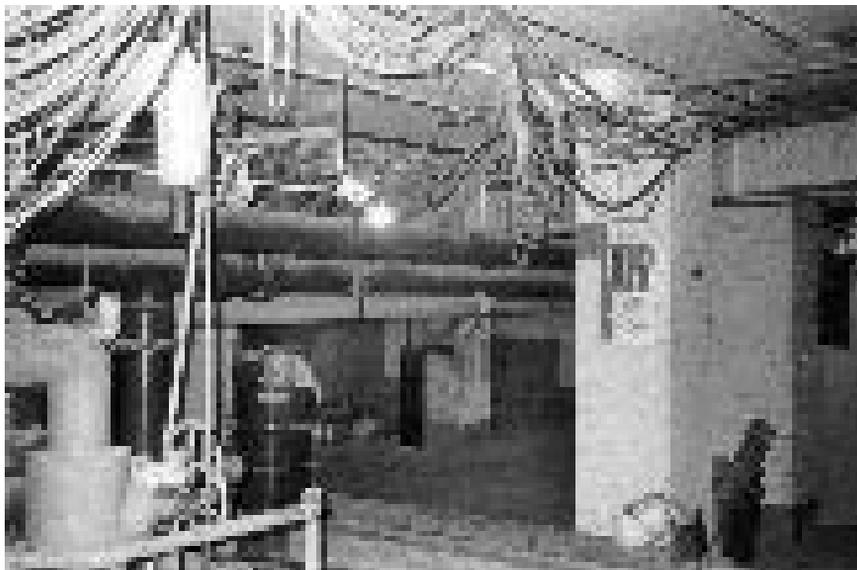
By the 1980s, the capitol's basement had become a choked maze of pipes and wires (above). The basement floor was lowered several feet, and conduit and ductwork laid beneath (below). (Department of Administration, Division of Facilities Development)

the grid was laid, the concrete floors were repoured. In keeping with the Master Plan, electrical outlets were added unobtrusively in the rotunda and in the nearby passageways.

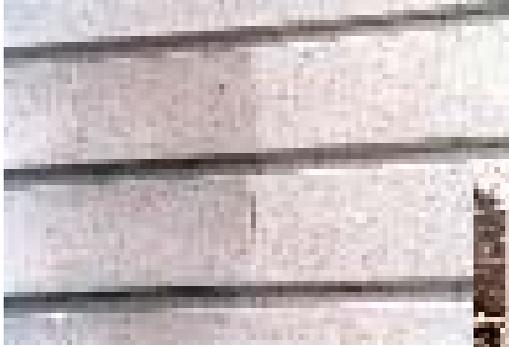
Exterior granite before and after sponge-jetting. (Kathleen Sitter, LRB)

White Bethel granite. It removed the grime without taking off any of the stone itself or damaging it. Every inch of the exterior had to be treated directly by sponge-jetting, which required the construction of scaffolding around the exterior of the capitol. This work was done in 2000 and 2001 independently of the interior work. The resulting restoration of the exterior walls to their original whiteness was particularly dramatic while the process was still underway and untreated gray portions of the walls remained for comparison.

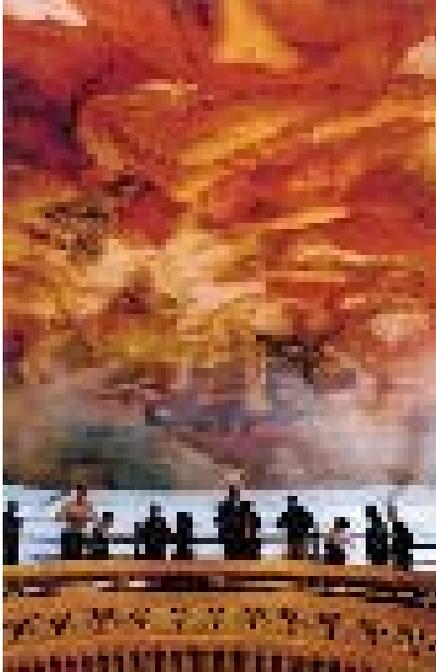
Edwin Blashfield's oculus mural had been damaged by tourists who were permitted unsupervised access to the dome during the capitol's early years. (Richard G.B. Hanson II)
