Restoring the vision: the story of Wisconsin's Capitol Building, from its construction in the early 1900s, to its recent renovation

*Restoring the Vision:
The First Century of Wisconsin's Capitol*

by Michael J. Keane
Photo Design by Kathleen Sitter
Legislative Reference Bureau

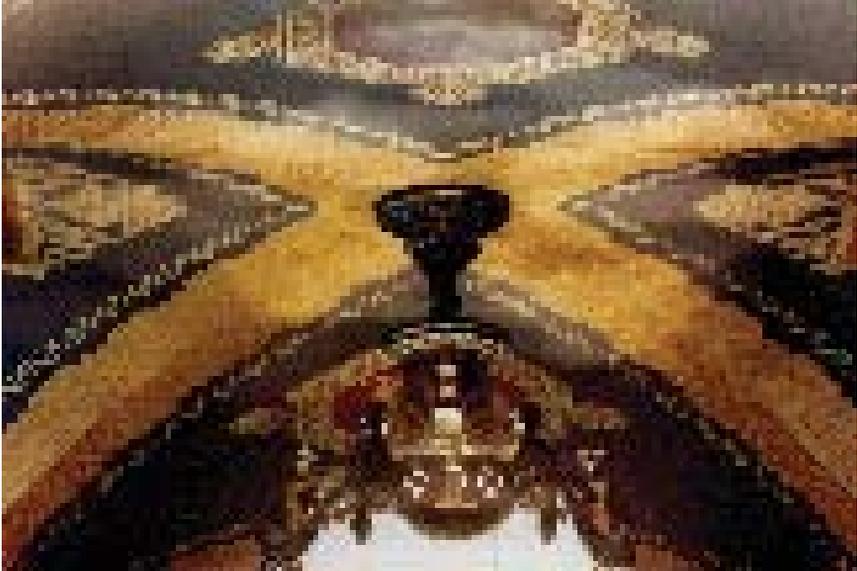
Decorative painting in the public areas of the capitol was one of the concerns addressed by the Capitol Master Plan. (Kathleen Sitter, LRB)

The Master Plan also addressed the state of artwork in the capitol. It expressed particular concern with the state of the decorative painting in the public areas of the building. Unlike the decorative schemes in the private areas of the capitol, the decorative painting in the public areas generally survived. A conservator's report, however, had noted varying conditions of deterioration and recommended that these early signs of decay receive immediate and ongoing attention. A regular program of maintenance for decorative painting was recommended. The plan called for some maintenance staff to receive training in the care of the capitol's artwork, as well as regular dusting and vacuuming of wall murals. The plan did not recommend any major restoration or conservation of artwork.

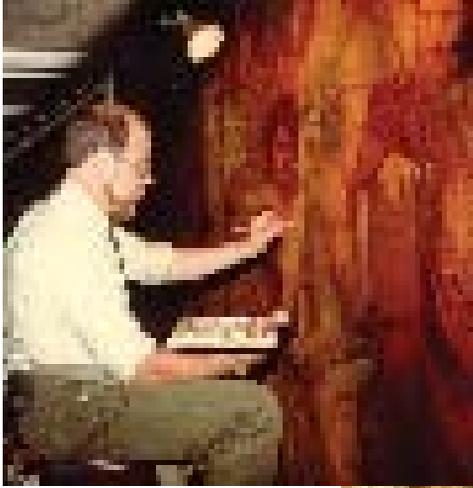
Restoration of the Assembly Chamber mural in 1988 (left). Further work was done on the decorative painting in the chamber when the west wing was closed in 1995 (below). (East Wing Architects LLC)

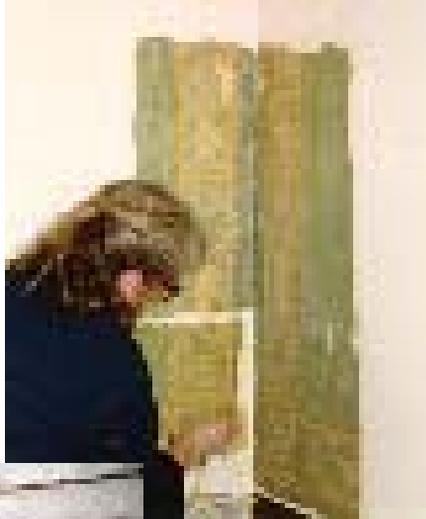
An additional preliminary step was to identify the original color and decoration of walls. To do this, workers conducted paint probes of walls determined to be original. This involved painstakingly removing many layers of paint that had been added over the years. With few exceptions, the original color had been painted over along with the decorative flourishes. When the original layer was revealed, it offered a clue as to how the room had looked when the capitol was new.

Paint probes involved removing layers of paint to reveal original color and design. (Gerylyn Schneider (above), Kathleen Sitter, LRB)

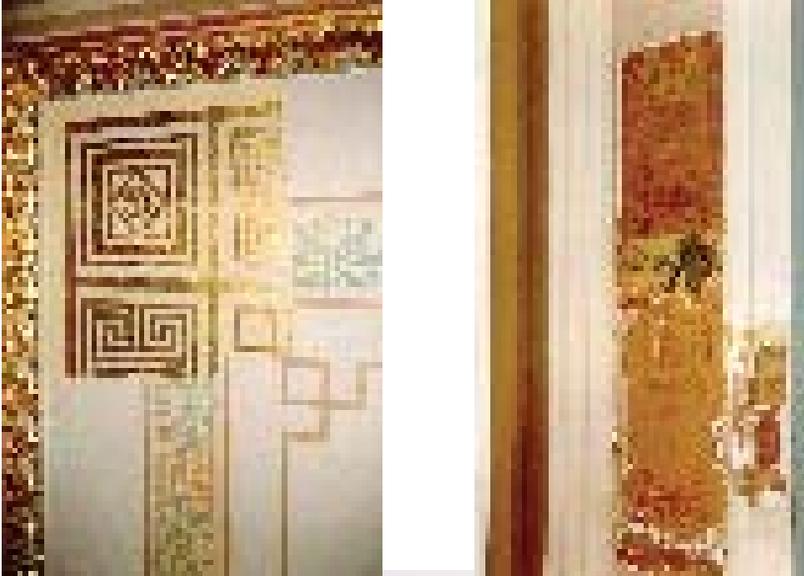
*Paint probes uncover the decorative schemes for the capitol through the decades.
(Gerilyn Schneider)*

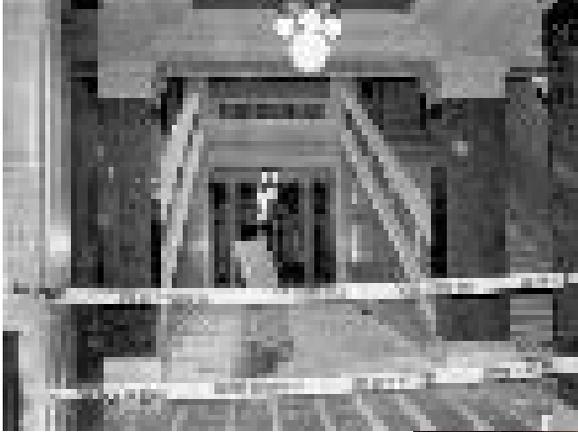
Areas of the capitol under renovation were closed to the public (left). Temporary plywood walls were erected to protect exposed surfaces (below). (Kathleen Sitter, LRB)

construction work. The first step taken in each wing, therefore, was to encase all exposed marble and granite surfaces with plywood in order to prevent damage. The plywood barriers, keeping the public out of wings being renovated, were one major piece of evidence to capitol visitors that something unusual was going on.

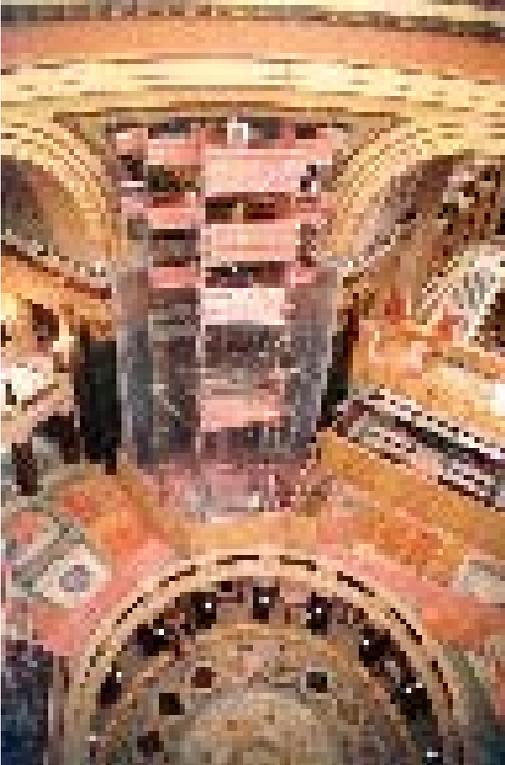
Scaffolding allowed conservation workers access to Kenyon Cox's mosaics. (Kathleen Sitter, LRB)

One of the thorniest problems faced in the whole 11-year renovation of the capitol was the deterioration of Kenyon Cox's glass mosaic work in the rotunda. In the course of removing decades of grime from the glass pieces, conservators found that some sections of the mosaics were detaching from the concave surface of the pendentives. The combination of this with the original tarnishing of the aluminum-based gilt left conservators with a problem. Would it be better to inject a nonreversible adhesive behind the glass pieces in order to keep them secure on the wall or to take the thousands of glass pieces down and reassemble the mosaics using some other form of adhesive? Eventually, it was decided that injecting adhesive would be the least invasive and least risky option for preserving this unique feature of the capitol. The deterioration of the gilt was left untreated, a testimony to the failure of the original method.

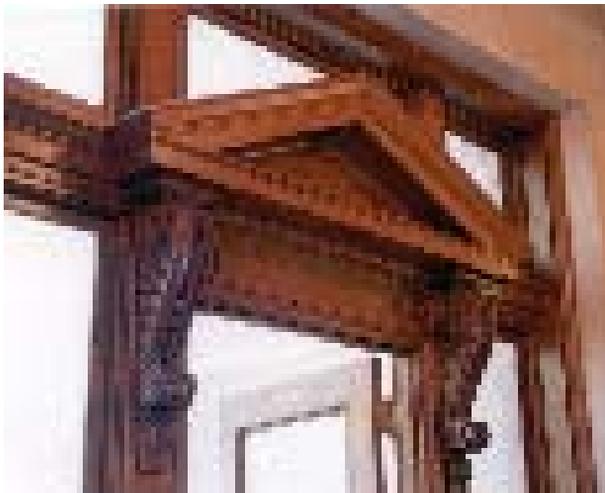
The capitol's woodwork was restrained to match its original appearance. (Kathleen Sitter, LRB)

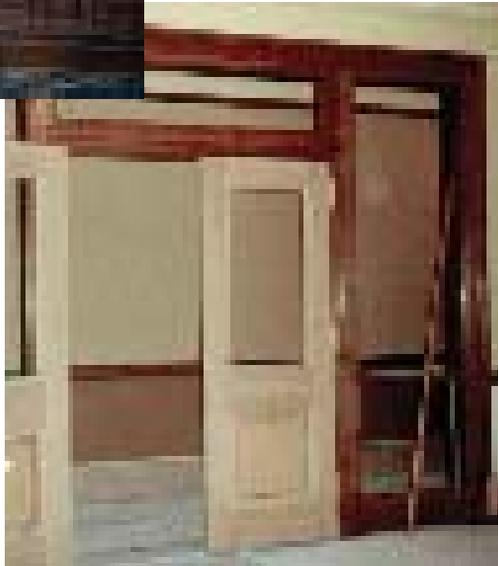
A mockup of proposed color and design (top) offers a contrast between the light stain originally used and the darker color introduced in subsequent years. (Kathleen Sitter, LRB). Doors were removed, stripped and restained (lower). (East Wing Architects LLC)

cherry, walnut, or mahogany, were used. The first step was to determine through probes what the original stain was. Once identified, the stain underwent chemical analysis so that it could be duplicated exactly. After the proper stain was decided upon, it was necessary to remove the wainscot, doors, and doorjambs, and strip them of their hardware and finishing. This was a complicated task as the typical capitol doorjamb contains 11 different pieces of wood. These pieces were stored after finishing to prevent damage by other construction work. The care taken with door wood and door hardware

hardware was carefully labeled and stored so that it could be easily reunited with the right doors when the time came. All told, there were around 300 to 400 doors to be refinished in each wing. The doorjambs often had been planed or otherwise modified over the years, so they were resquared.
