MacKenzie Environmental Education Center Study
Wisconsin Department of Natural Resources and
Wisconsin Department of Administration
October 2014

Section 9101 (2i) of 2013 Wisconsin Act 20 directed the Department of Administration (DOA) to conduct a “thorough review of the existing status and condition of the buildings, structures, and animal enclosures at the MacKenzie Environmental Education Center.” The study was to include “a description of the maintenance and repairs that are necessary for the buildings, structures, and animal enclosures with an estimate of the costs of doing the maintenance and repairs.” The DOA Division of Facilities Development (DFD) engaged the services of INSPEC, Inc., an independent engineering/architectural firm to undertake the study.

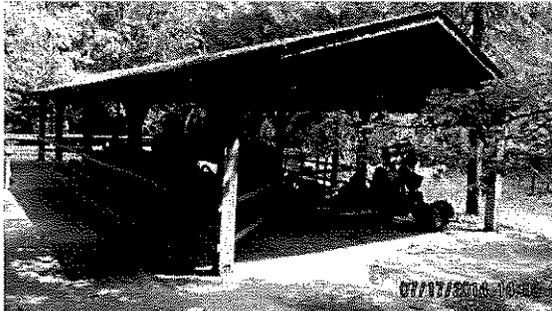
The Saw Mill/Log Shelter structure was constructed in 1964. It is a 1,000 GSF structure that provides shelter for the log saw and ancient log on display.

The shelter structure is unique and dedicated to the log and saw display. No repairs required to the facility.

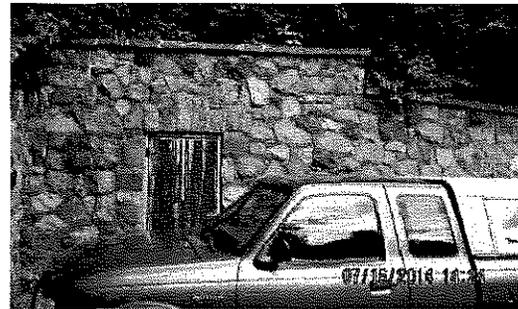
Storage (In-Hill)

The Storage structure is a 240 GSF concrete structure constructed in 1937 and located in the side of the hill adjacent to the Work Shop. It was constructed for cool storage in conjunction with the adjacent rabies research operations.

The Storage structure has very limited specialized use. No repairs are required.

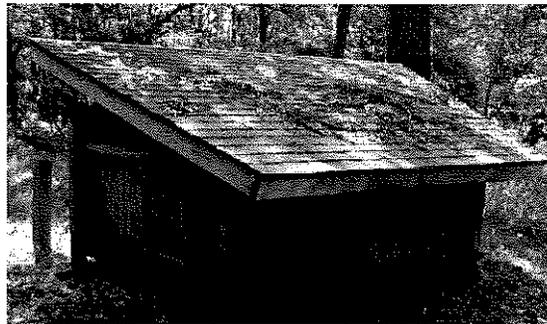
The **Deer Shelter** is a 12' x 9' freestanding shed roof structure constructed within the deer enclosure fencing. The weathered wood shelter was constructed in 1978. The structure is substantial and very well constructed and does not require repair.
